**Flood Control Project Maintenance
Levee Inspections**

Fall 2014 Levee Maintenance Deficiency Summary Report

Sacramento River Basin

Reclamation District No. 2068 Yolano

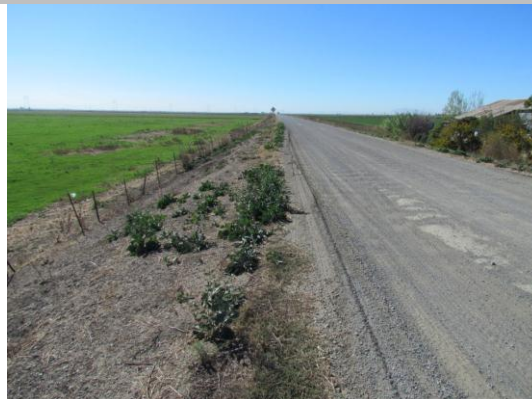
Photo 1 of 1 : FA_2014_RD2068_193_1_20141126_00001.jpg

LM Start	0.51	Rating **	A	Issue No.	1
LM End	5.50	Issue Type +	Ma	Location *	WS
Category	Earthen Levee			GPS Latitude/Longitude	
				Start	End
Item	Vegetation			38.401158 °	38.329087 °
				-121.693845 °	-121.694105 °
DWR ID	DWR_RD2068_01_f_2014_1				
Action/Comments					
Control annual grass and weeds on the levee slopes and easements. Inspector Comments: Slopes has been burned and dragged.

Looking downstream from waterside slope RD 2068 Levee mile 0.51.

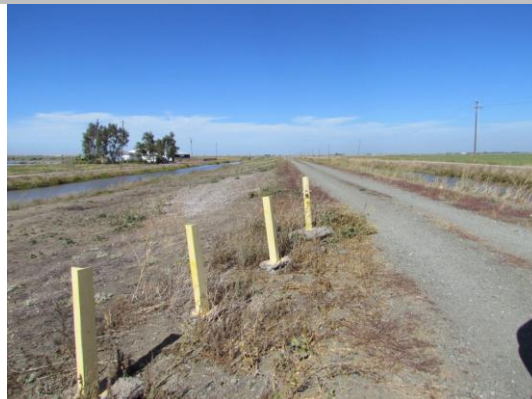
Photo 1 of 1 : FA_2014_RD2068_194_9_20141126_00004.jpg

LM Start	0.00	Rating **	A	Issue No.	9
LM End	0.00	Issue Type +	Ma	Location *	LS
Category	Earthen Levee			GPS Latitude/Longitude	
				Start	End
Item	Vegetation			38.358608 °	38.358608 °
				-121.740390 °	-121.740390 °
DWR ID	DWR_RD2068_02_f_2014_9				
Action/Comments					
Control annual grass and weeds on the levee slopes and easements. Inspector Comments: Looking downstream from landward levee slope slope was mowed.

Looking downstream from levee mile 0.00 along unit 2, 2068 at the landward levee slope.
